Folgate Cottage

Discussion with Edwin Rose, archaeologist at Norfolk Archaeological Unit,
Gressenhall

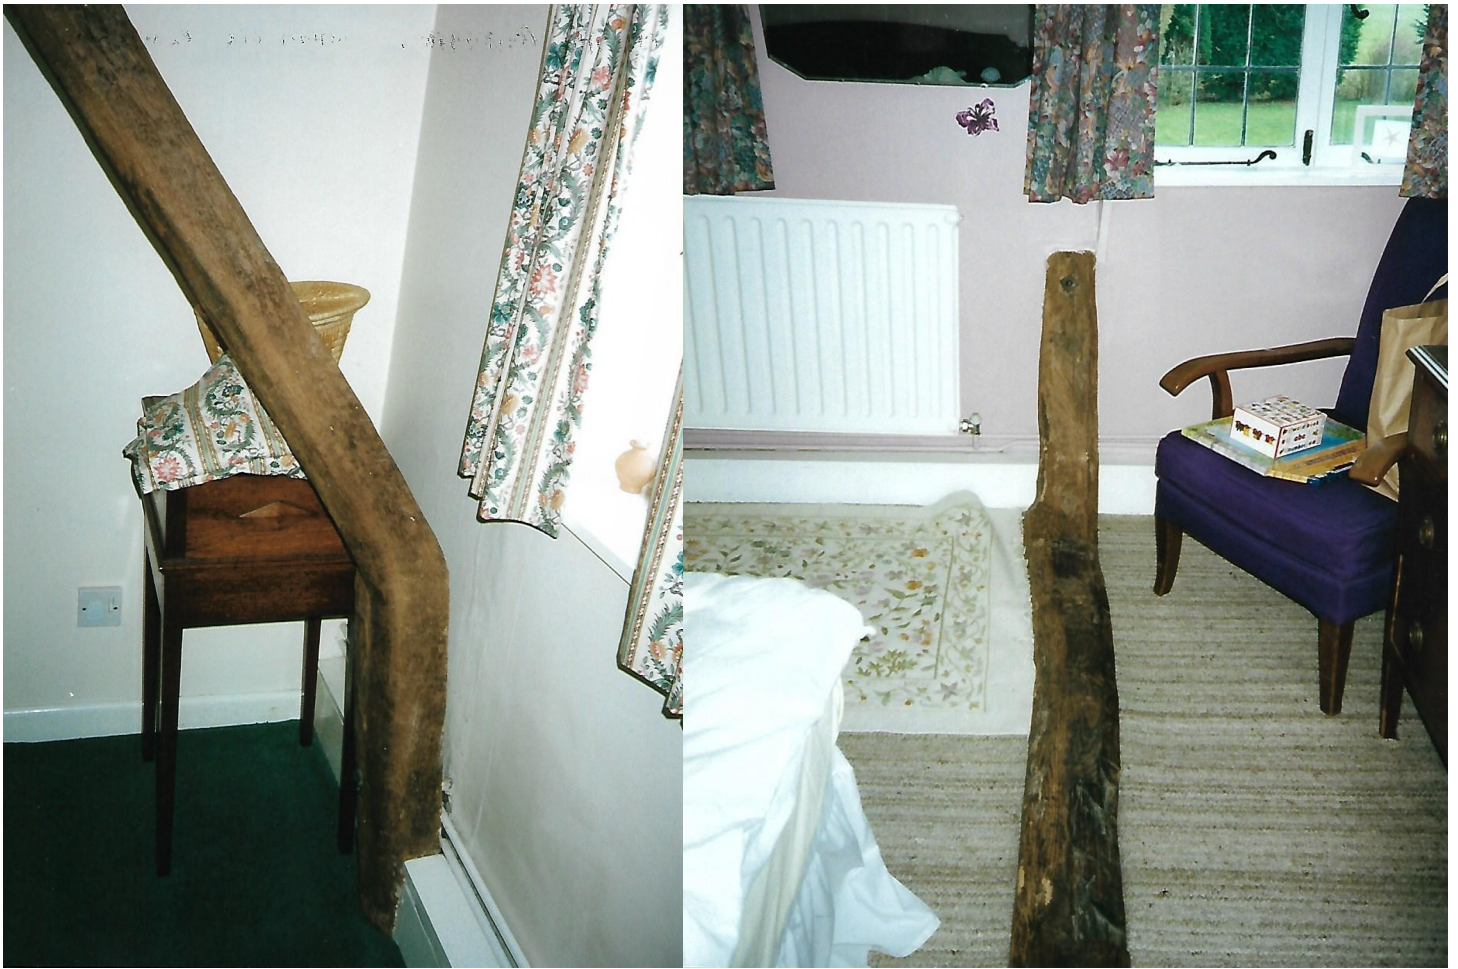
1. Beams in bedroom. Agrees that this looks like a raised cruck. Appears to be around sixteenth century. If this was put in when roof raised then the house is even older than that – though it could be from the original roof.
